Article

A Simple Field Test to Evaluate the Maintenance Requirements of Permeable Interlocking Concrete Pavements

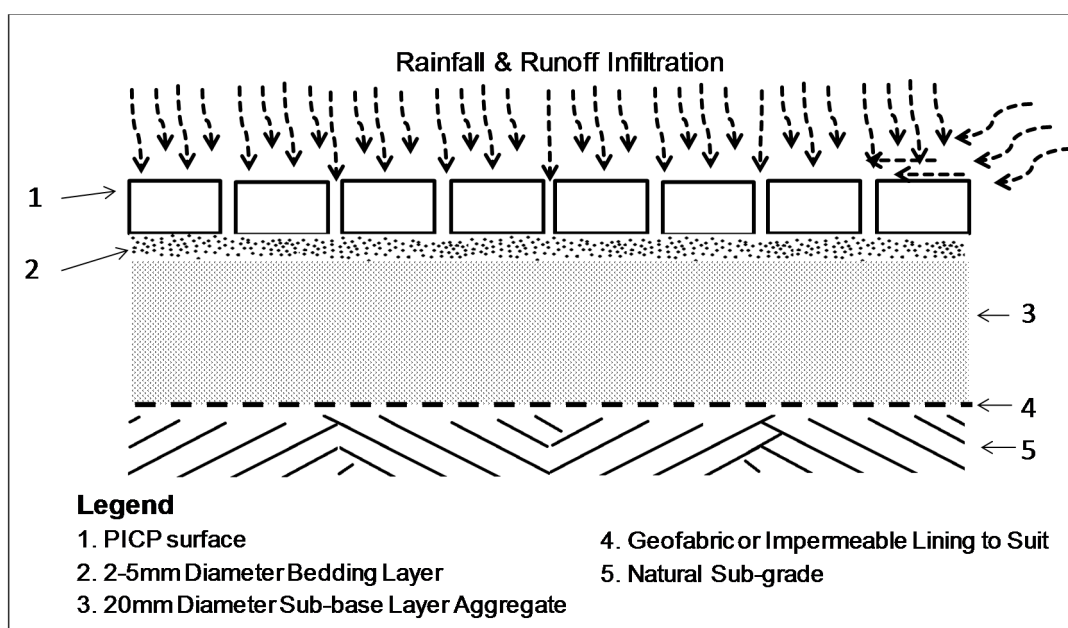
Figure 1. Typical Permeable Interlocking Concrete Pavement (PICP) structure.

The majority of modular permeable pavement systems are Permeable Interlocking Concrete Pavements (PICPs) which consist of concrete blocks or pavers with open joints which allow infiltration between the pavers (Figure 1). The stormwater infiltrates through the surface and bedding layers and then into the surrounding soil and groundwater, or discharged into conventional stormwater drainage.

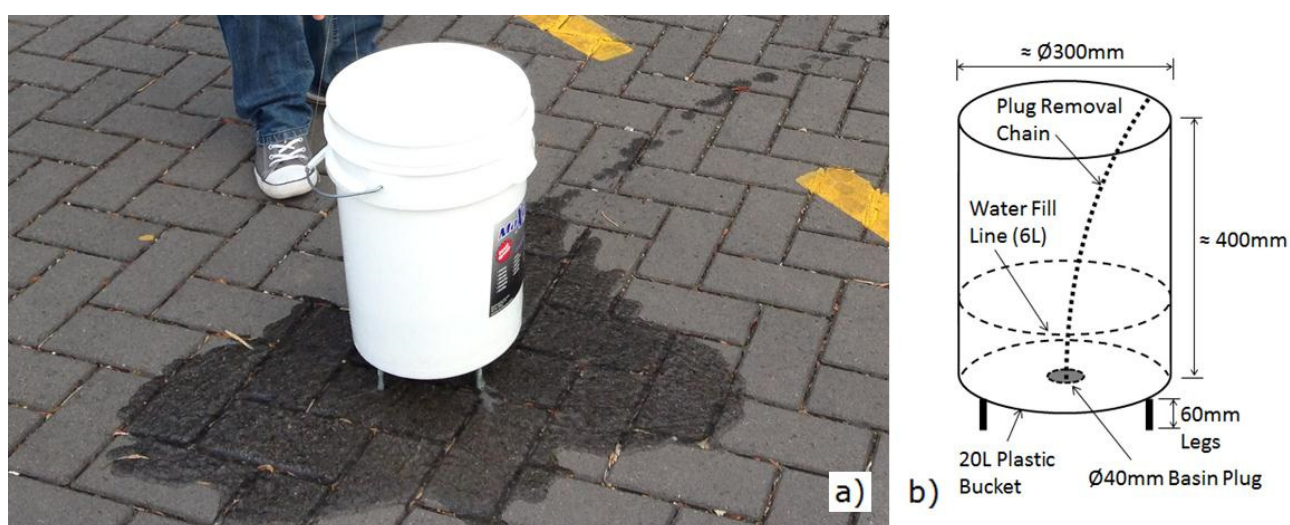
Figure 3. Stormwater infiltration field test (SWIFT) Infiltrometer used in this study. (a) SWIFT in use; (b) SWIFT dimensions.

The SWIFT method uses a commonly available 20 L plastic bucket, with a 40 mm diameter hole cut into its base, to estimate PICP infiltration rates (Figure 3). As the SWIFT test relies on counting the number of fully wetted bricks, no pre-wetting of the surface is required. If a test is to be repeated at precisely the same location, a minimum antecedent dry period of 24 h is recommended. The SWIFT infiltration estimation method involves the following steps:

- i) Place bucket over one of the pavers of the surface to be tested so that the drainage hole is located directly above the centre of the paver;
- ii) Insert plug into bucket drain hole (making sure it fits snugly to prevent leaks) and fill bucket with 6 L of water;
- iii) Remove plug using attached chain or rope and allow all water to flow out of the bucket and onto the paving surface. Remove SWIFT device;
- iv) Count and record the number of individual bricks that are fully-wet across their entire surface (this step may be photographed for later analysis);
- v) Estimate the average infiltration rate, and categorise the state of pavement blockage and maintenance requirements using the information in Table 2 as a guide.

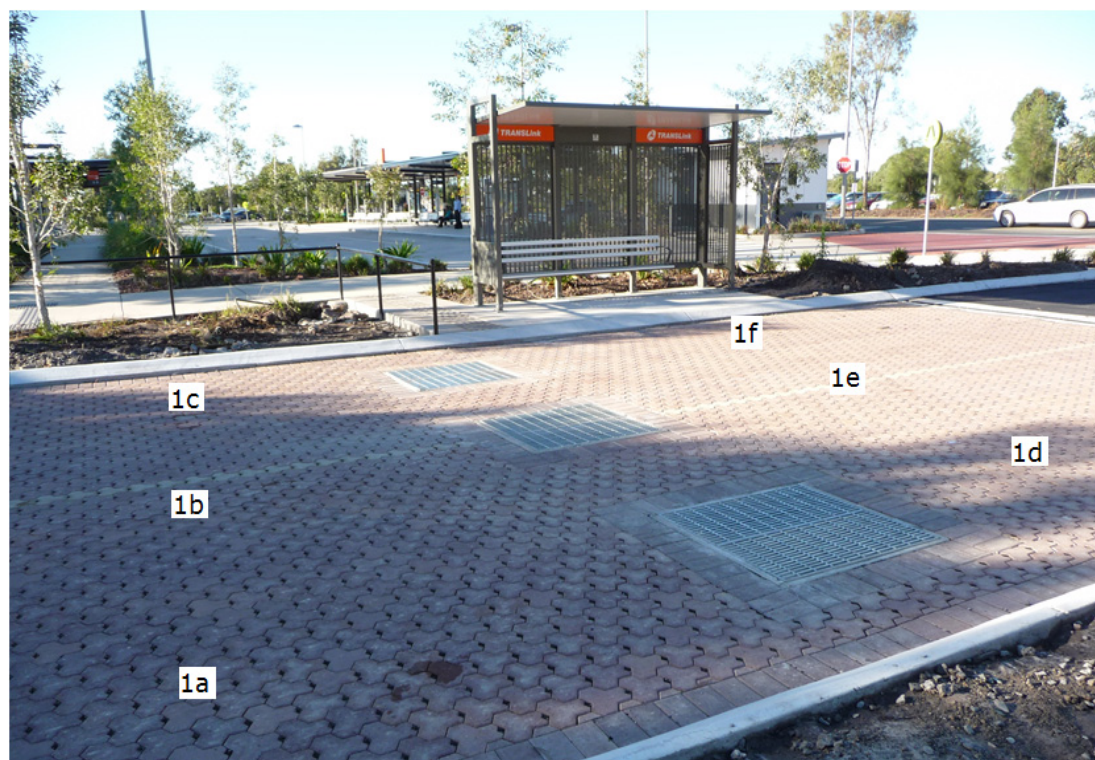
Figure 4. Six sub-site test locations at Site 1.

Field testing of both methodologies was carried out on a range of PICP pavement types, at three different PICP installations across the Sunshine Coast, Australia. The three installations were located at Sippy Downs (Site 1), Cotton Tree (Site 3) and Mary Cairncross Reserve, Maleny (Site 2), and incorporated a range of different construction techniques (Figures 4 and 5). The test pavement at Site 1 was comprised of six sub-sites (1a–1f, Figure 4) incorporating three different construction techniques, including varying aggregate sub-base depth layers, and different combinations of geotextile and impermeable layers. Geofabric liners were installed below the aggregate sub-base at Sites 1a and 4a and

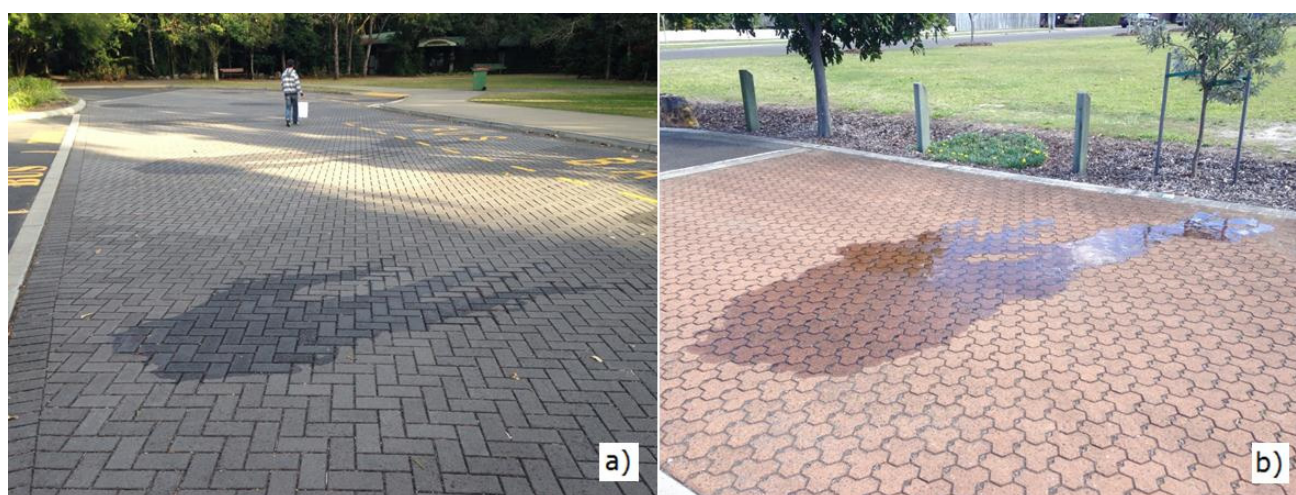
Figure 5. Site 2 (a) and Site 3 (b) PICP test locations.

below the aggregate bedding layer at Sites 1–3. Site 1 was in effect six different pavements. Site 3 (Figure 5b) was a suburban roadside carpark area of approximately 750 m². The construction of Site 3 included a 50 mm deep sand bedding layer and a geofabric liner between the sand and the sub-base aggregate.

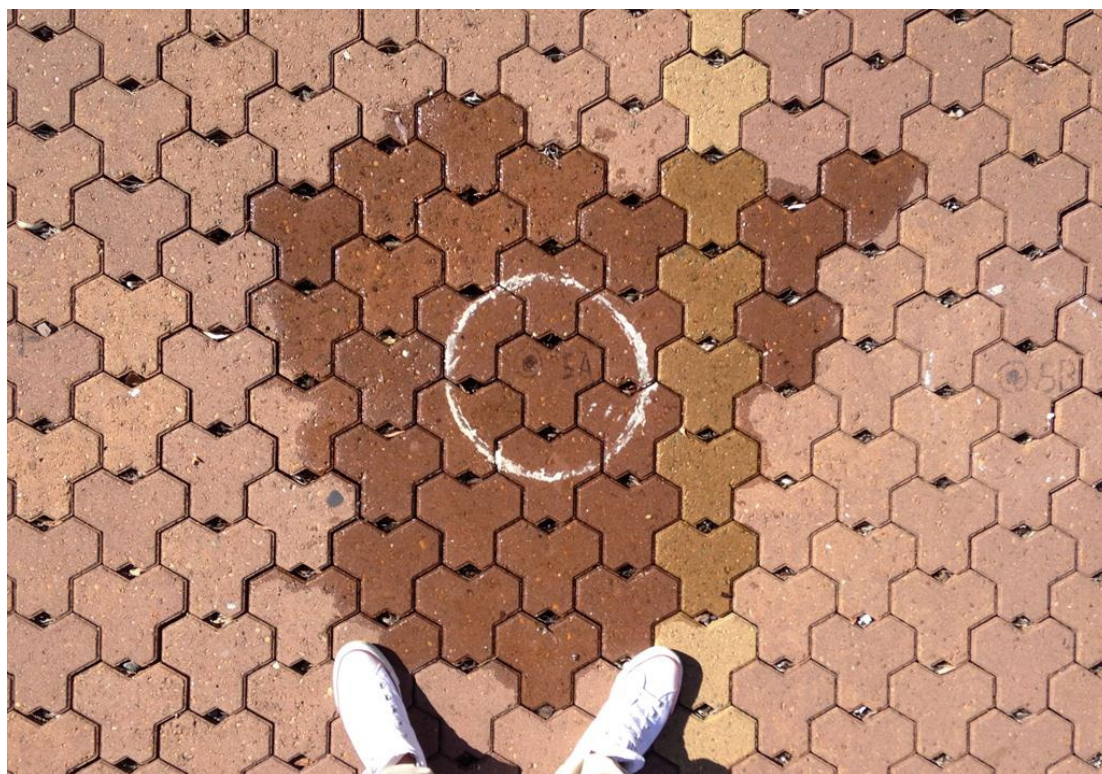
Figure 6. Photograph showing SWIFT water stain (30 Fully-wetted bricks) over the precise location previously tested using the SRIT methodology.

The two replicates of each test method (C1781M-14a and SWIFT) were carried out at precisely the same location at each site (Figure 6). Replicate testing was undertaken on different days to ensure the PICP surface was dry to allow for the number of wet bricks to be counted.

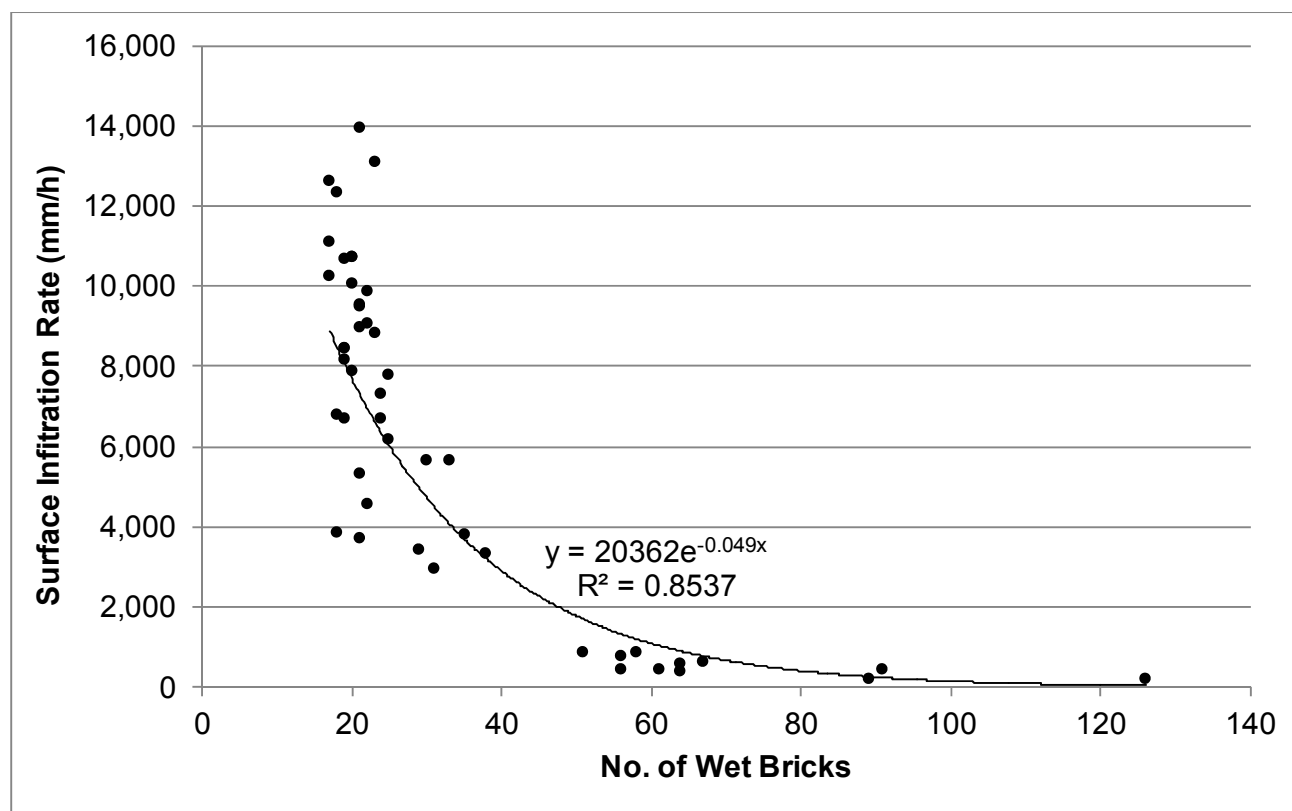
Figure 7. Comparison of PICP infiltration rates using SRIT and SWIFT methods.

Figure 7 shows the surface infiltration results observed using the SRIT test with the number of wet bricks observed after the SWIFT test for each of the test locations on Sites 1 and 2. The results of 47 different test locations are shown on Figure 7. An exponential trend line and its equation are also included on Figure 7. These show a correlation coefficient between the data points and the trend line of 0.854 which is quite high and demonstrates a good correlation. The general trend shown in Figure 7 is that as the surface infiltration rate decreases, the number of bricks wet by the SWIFT test increases. This result was anticipated and clearly demonstrates the feasibility of using the SWIFT test results to predict surface infiltration rates and potential maintenance requirements.

The SWIFT test was still undertaken at the Site 3 test locations and the average number of wet bricks was 168 for these tests. Accordingly, Figure 7 does not contain any test data from Site 3. Inputting a value of 168 into the Figure 7 trendline equation produces an approximate infiltration rate of 5 mm/h (used in Figure 8) which is consistent with being effectively fully blocked.

Using the results shown in Figure 7, it was possible to relate the approximate number of wetted bricks expected from the SWIFT test to the infiltration rates and blockage categories listed in Table 1. Previous research by Borgwardt [7] investigated the reduction in PICP infiltration capacity over time. He found that the infiltration capacity of PICPs typically reduced exponentially to around 20% of the newly-installed infiltration rate after approximately 10 years in service. By combining Borgwardt's [7] results with those in Figure 7, suggested PICP maintenance requirements were estimated based on the SWIFT test results. These are shown in Table 2. It must be noted the maintenance intervals suggested in Table 2 are indicative only and should only be used as a general guideline.

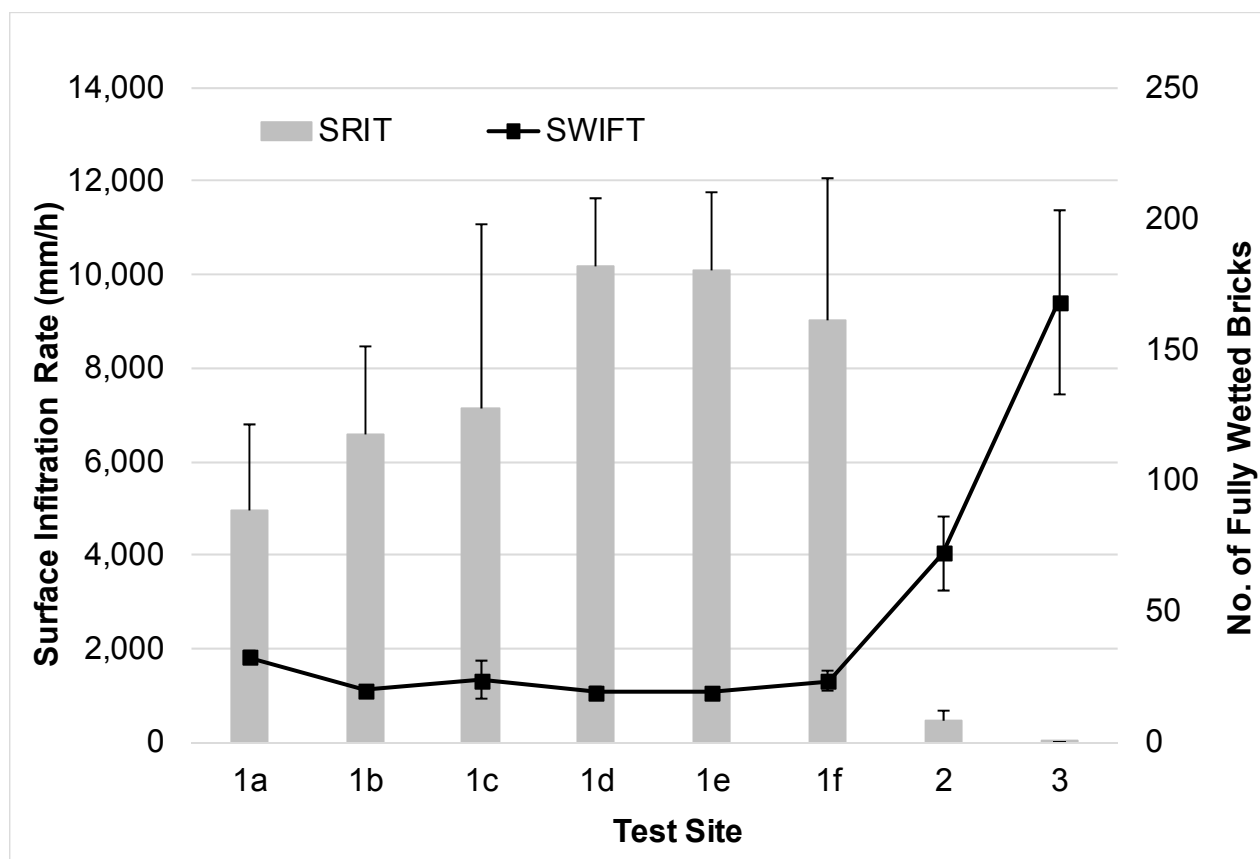
Figure 8. Comparison of PICP infiltration rates (\pm Standard Deviation) using SRIT and SWIFT methods.

Infiltration rates observed using both the SRIT and SWIFT methods varied between sites (Figure 8). Infiltration rates were substantially higher for all Site 1 tests compared with Sites 2 and 3. Average infiltration rates varied between 5 mm/h (calculated for Site 3) and 10,192 mm/h (Site 1d) using the SRIT. Figure 8 again demonstrates that the number of fully wetted bricks increased with decreasing infiltration rates. At the sites with lower measured infiltration rates during operation of the SWIFT method, counts of the number of wetted bricks increased six-fold (mean values ranged between 23 and 120). This shows a clear inverse relationship between infiltration rates and number of wet bricks, as expected.
